PMT GUIDE # 10

PURPOSE OF THIS GUIDE

To review existing masonry parapet walls and related 'flat' roof systems of existing church structures in consideration of maintenance and repair to insure their integrity.

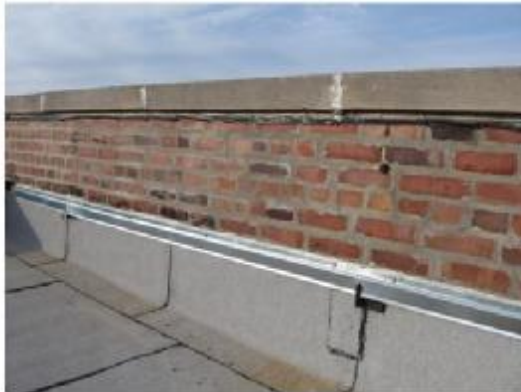
Flat roof flashed to brick parapet— good example with metal cap flashing, membrane under coping

- 1) All base flashing sealing the roofing system to parapet walls must be compatible with the roofing system selected. Ideally, the flashing should extend up the full height of the parapet wall and over the wall top to develop a single system. If the parapet wall is high, the base flashing should extend a minimum of 8" and preferably 12" above the roofing level. Depending on the roofing system, cant (angled) strips at the wall base may or may not be required. Flashings that do not extend the full wall height have the top edge counter-flashed with thru-wall metal flashing or termination bar.

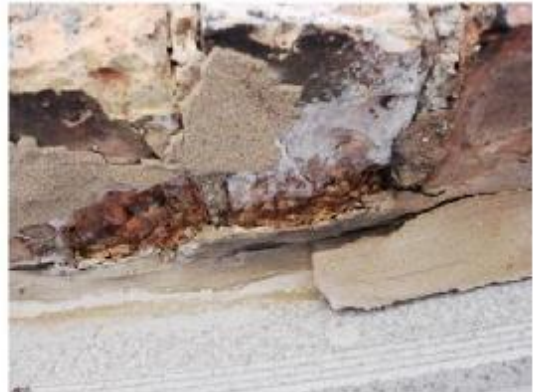
Brick parapet completely disintegrated from water penetration and freezing

- 3) Parapet walls: Are solid masonry construction, and are a vertical extension of the building wall systems. Evidence of moisture and freeze/thaw penetration includes loose and/or open mortar joints, spalled unit faces, loose masonry units and efflorescence. Defective joints require removal of material and re-pointing with new mortar. Existing 'surface tuck-pointing' of in-place joints probably hides defective joints, and is not an effective tuck-pointing technique. Remove and replace mortar joints to a depth at least equal to the width of the joint. Replace cracked and/or chipped masonry wall and coping units. All replacement units to be 'in kind' or original units.

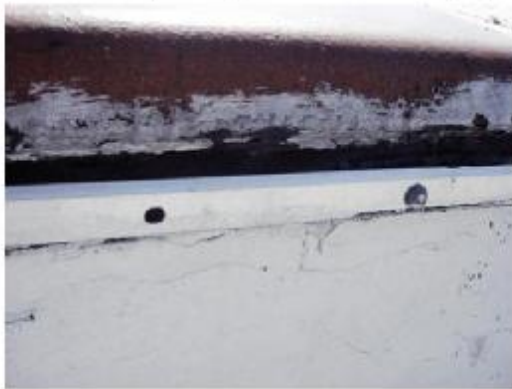
Wood termination bar for roofing at parapet. An inferior installation

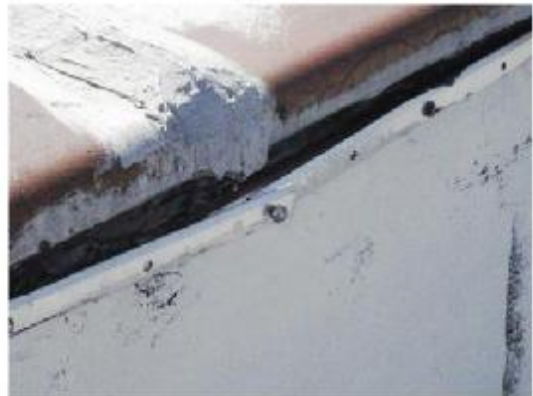
Wood termination bar failure admits water to parapet (see results below)

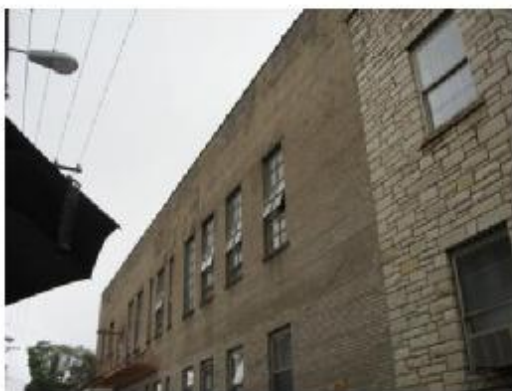
Note dark patches on brick indicating soaking from water penetration in the parapet

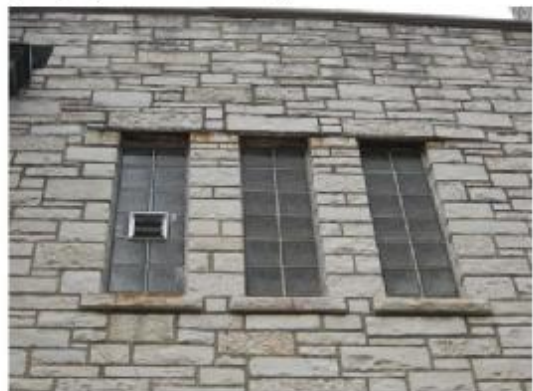
Lintel rusting expansion due to water from parapet: note bowing out, cracking of masonry

- 5) A final thought on parapet walls and copings: Delayed or 'forgotten' maintenance of these components promotes the potential intrusion of excessive moisture that, over a period of time, will cause damage to masonry unit(s) and wall integrity and will be a contributing factor of rusting and spalling of steel lintels particularly over wall openings (windows, doors) in the floor directly below the roof system. Repair/removal and restoration of the wall system, together with associated roofing and flashing systems will be costly; maintain a program of timely inspections and maintenance.

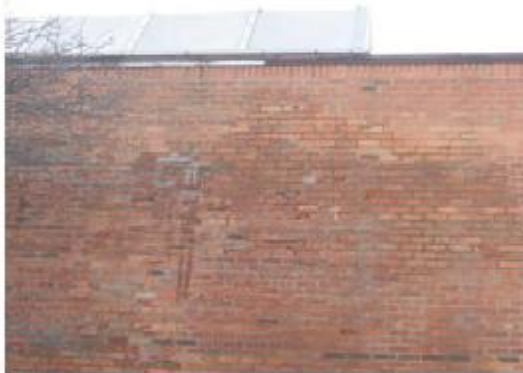
Note open brick joints and ice forming from water in the parapet and wall below

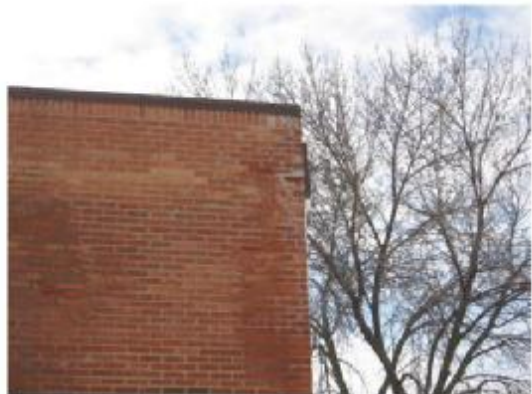
Note soaking and water of brick at corner due to poor flashing and/or scupper design

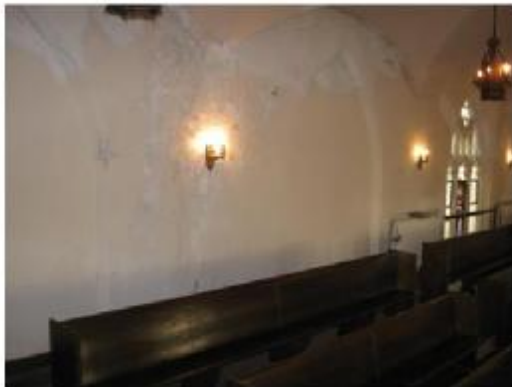
Note extent of sanctuary plaster damage due to poor flashing at parapet—since repaired.

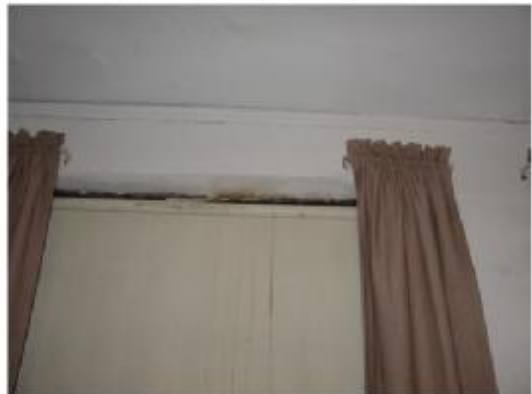
Note rusting lintel at top of window due to failure of flashing and open brick joints at roof above

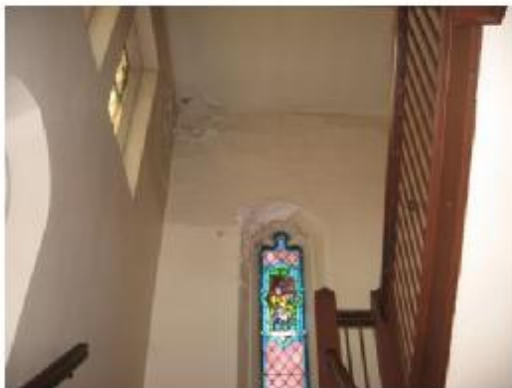
Note plaster damage at ceiling and stained glass window due to flashing failure above

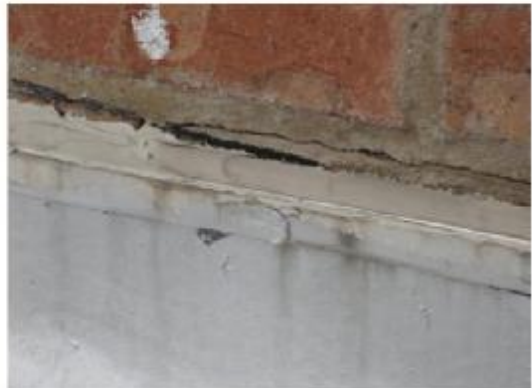
Note extended crack in brick joint resulting in ceiling damage in three rooms below
